Memorandum

Date: September 28, 2018

*Subject: Summary of Oversight of Cap Inspection at River Mile 10.9
September 10–11, 2018
Lower Passaic River Restoration Project*

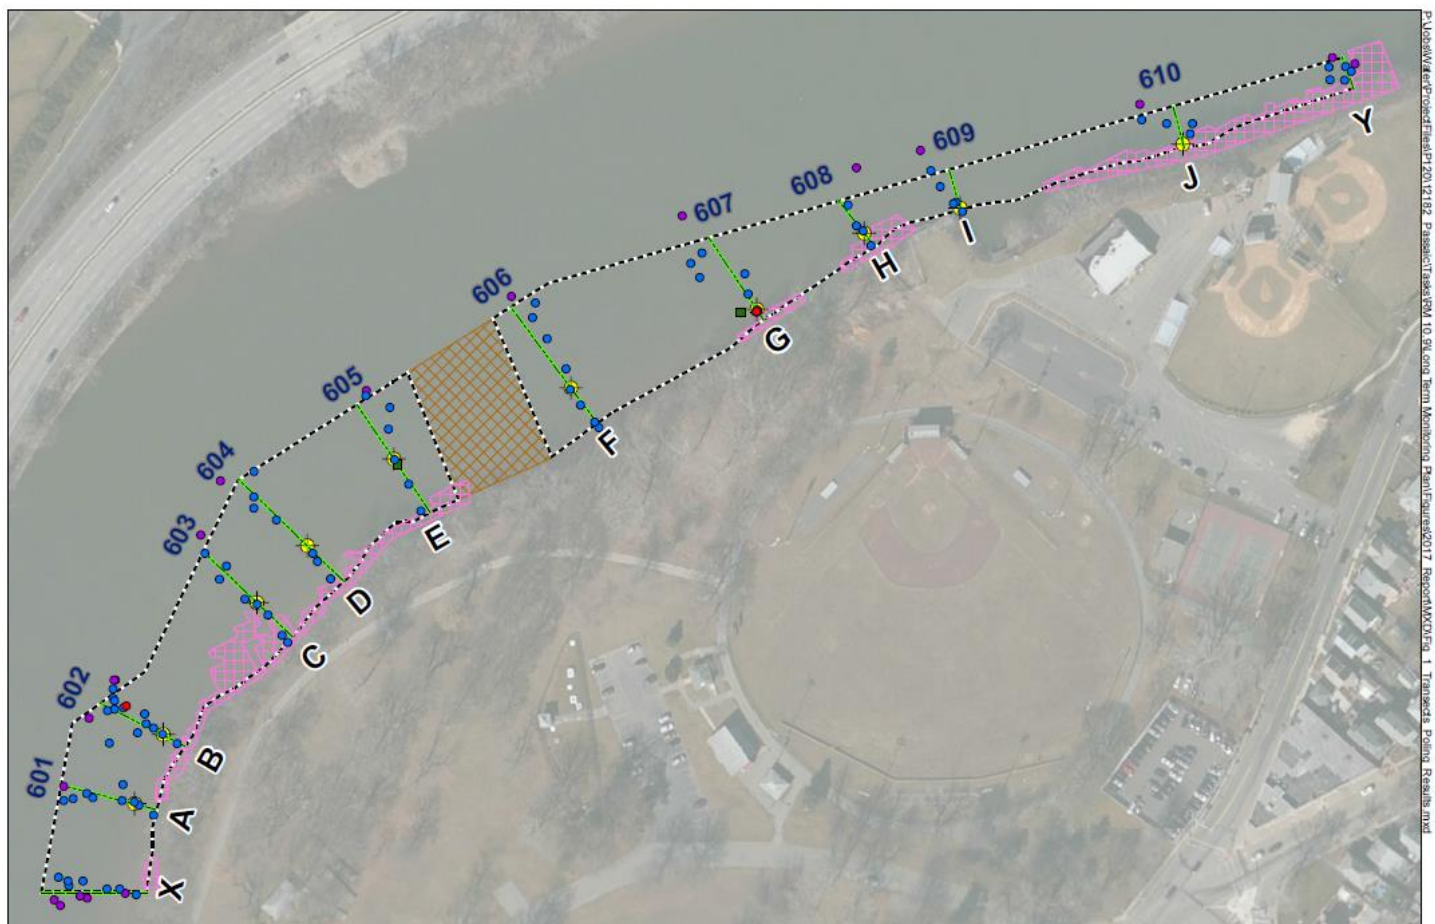
Figure 1
Transect Poling Results, August 2017
Annual Cap Inspection

The transects are presented in Figure 1 and are the same as the transects utilized during the 2017 inspection event. The poling points displayed in Figure 1 are from the August 2017 (not 2018) cap inspection and are provided for historical reference purposes only. GPS coordinates of the September 10-11, 2018 cap inspection poling points have not yet been received from the CPG as of the date of this memorandum. Photographs of field activities are presented in Attachment 1. A copy of the field logbook notes is provided in Attachment 2.

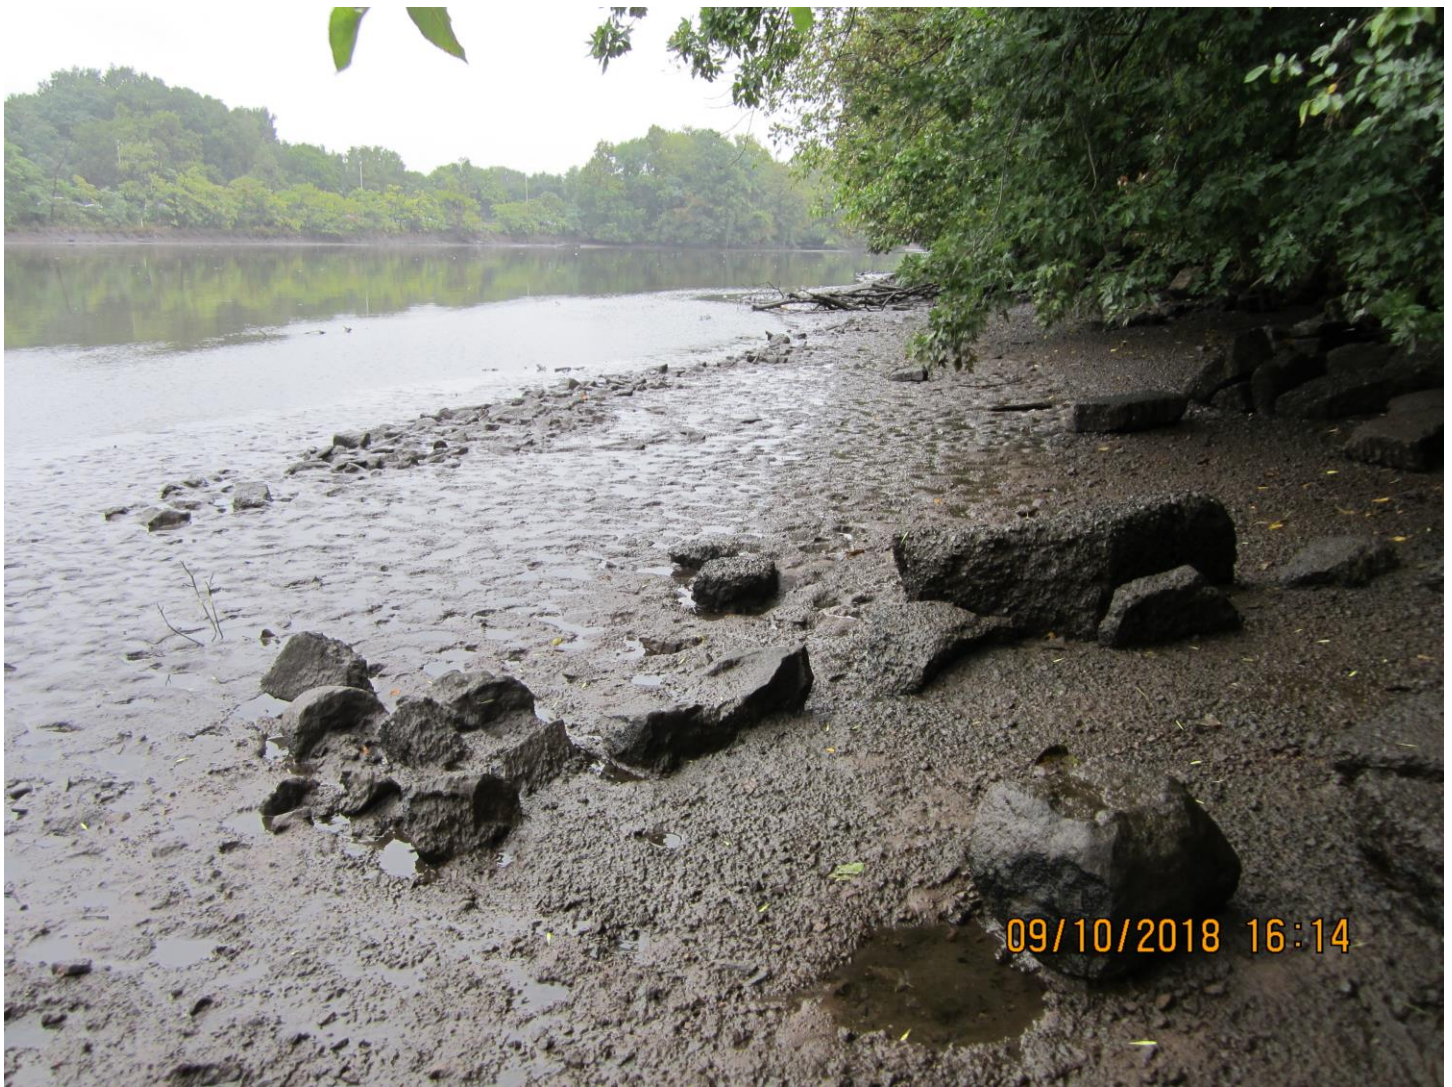
Photograph 1: Area of Transects G and H facing north (near low tide)

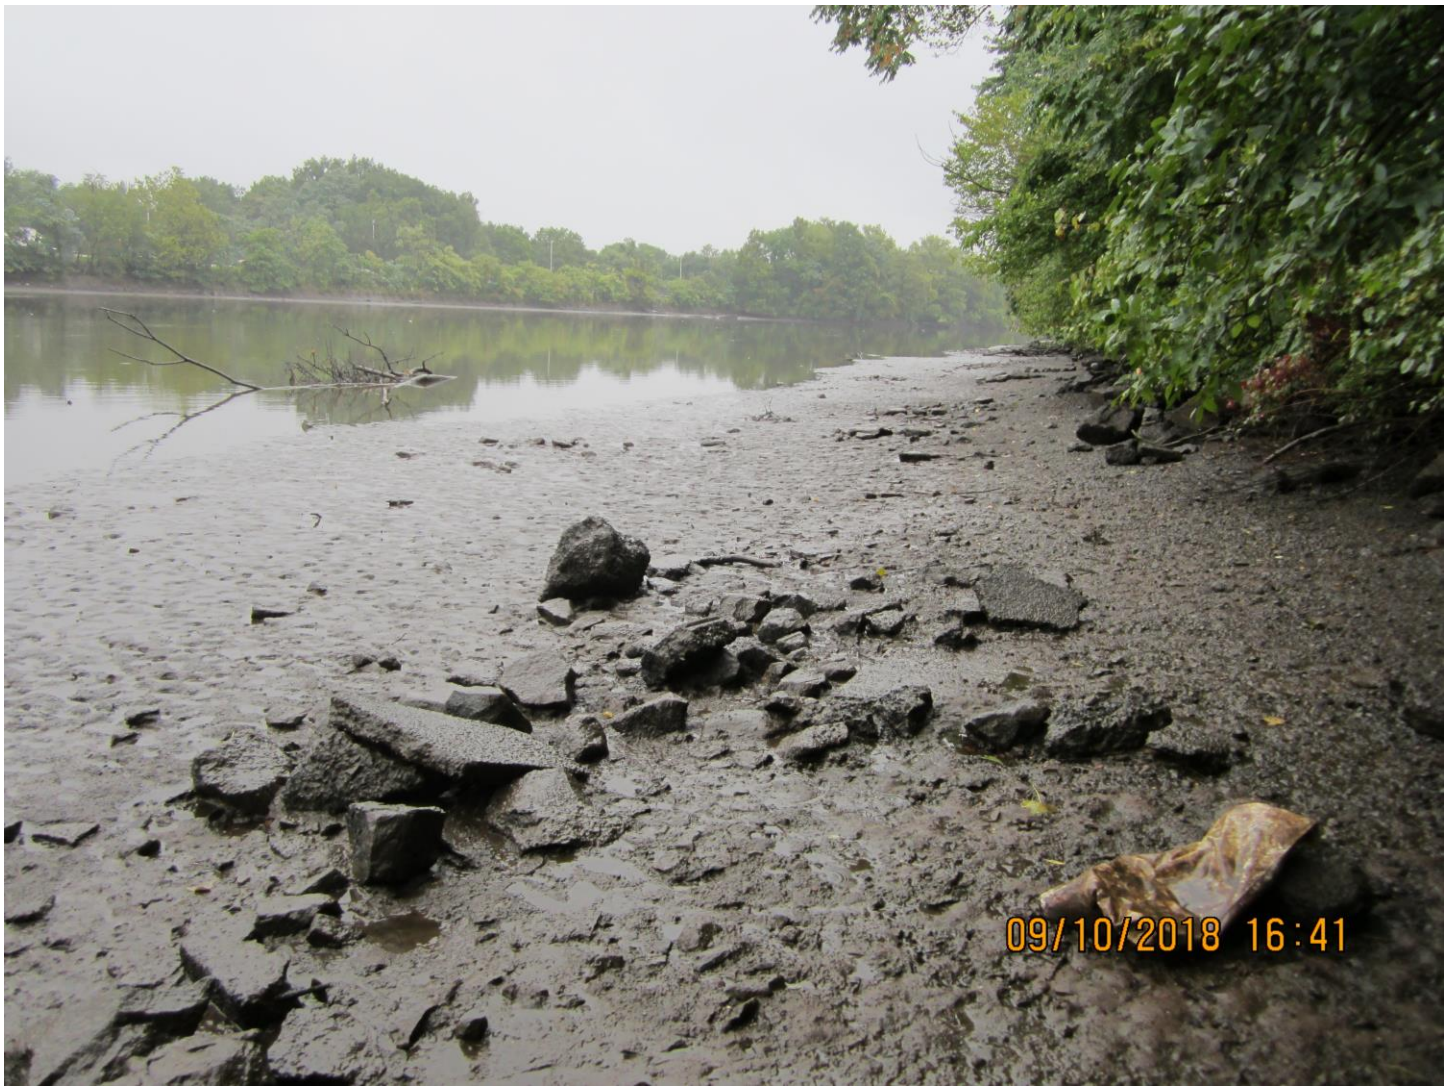
Photograph 2: Area of Transect F facing north (near low tide)

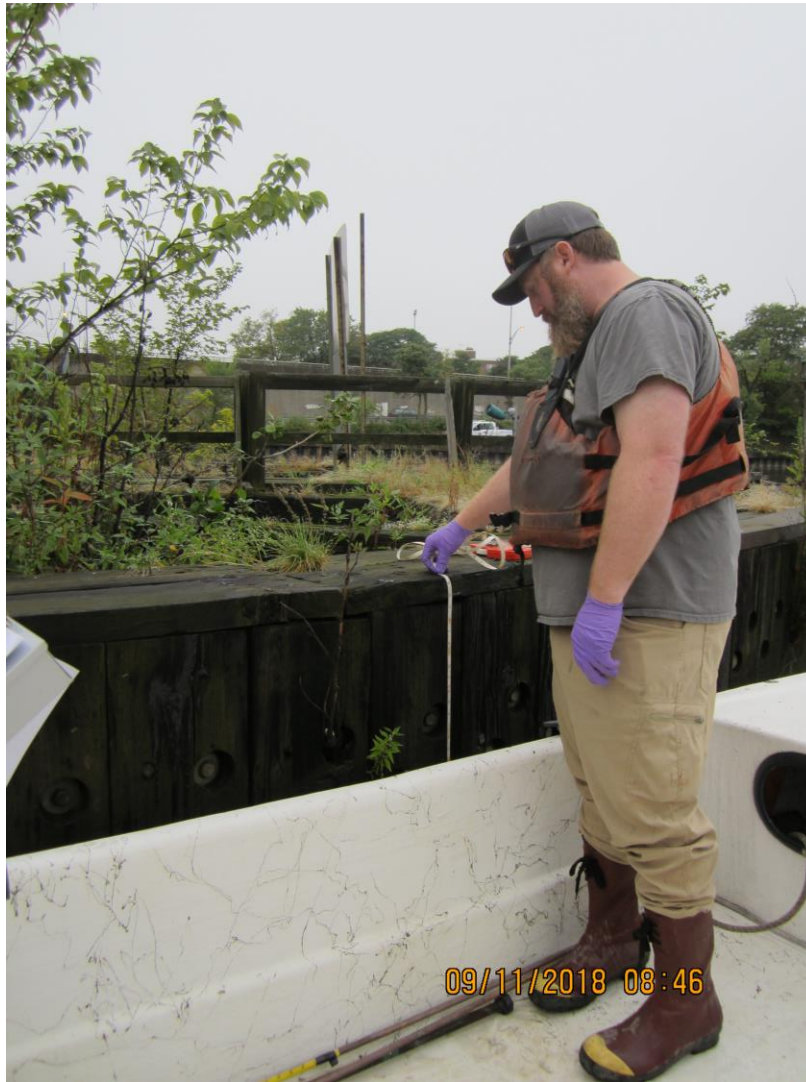
Photograph 3: Measuring depth to water surface from survey benchmark at Avondale Bridge

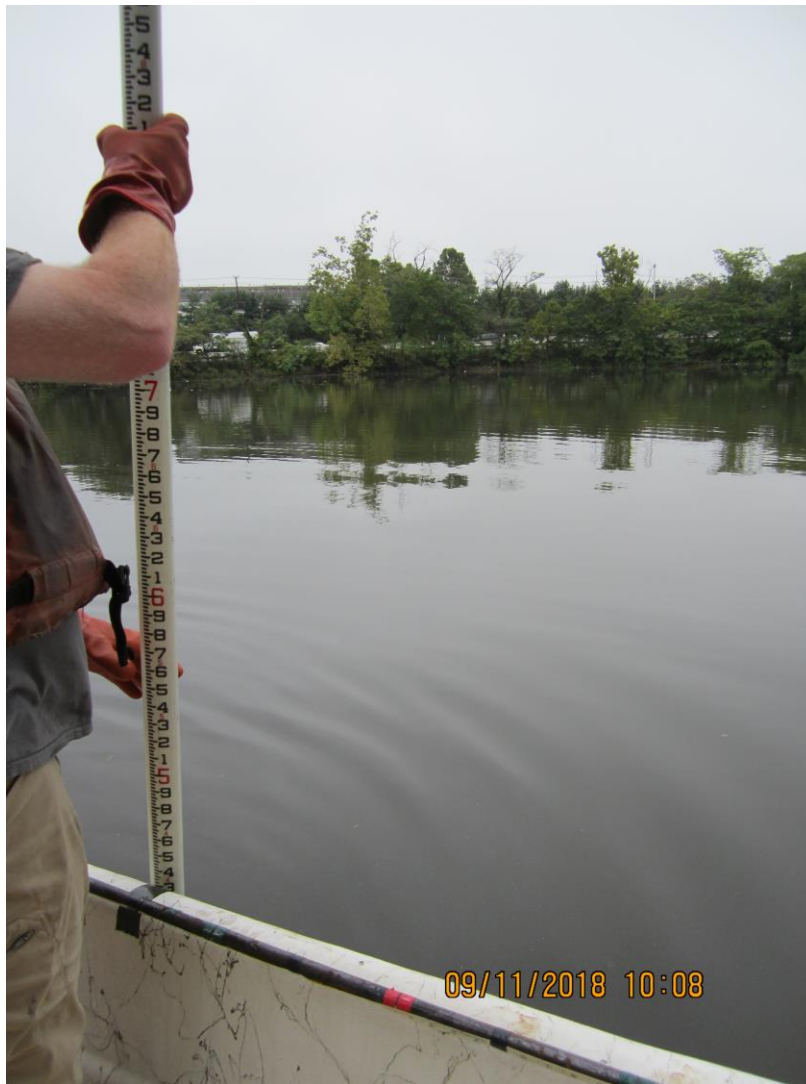
Photograph 4: Measuring depth to sediment with telescoping measuring pole at D-1 location

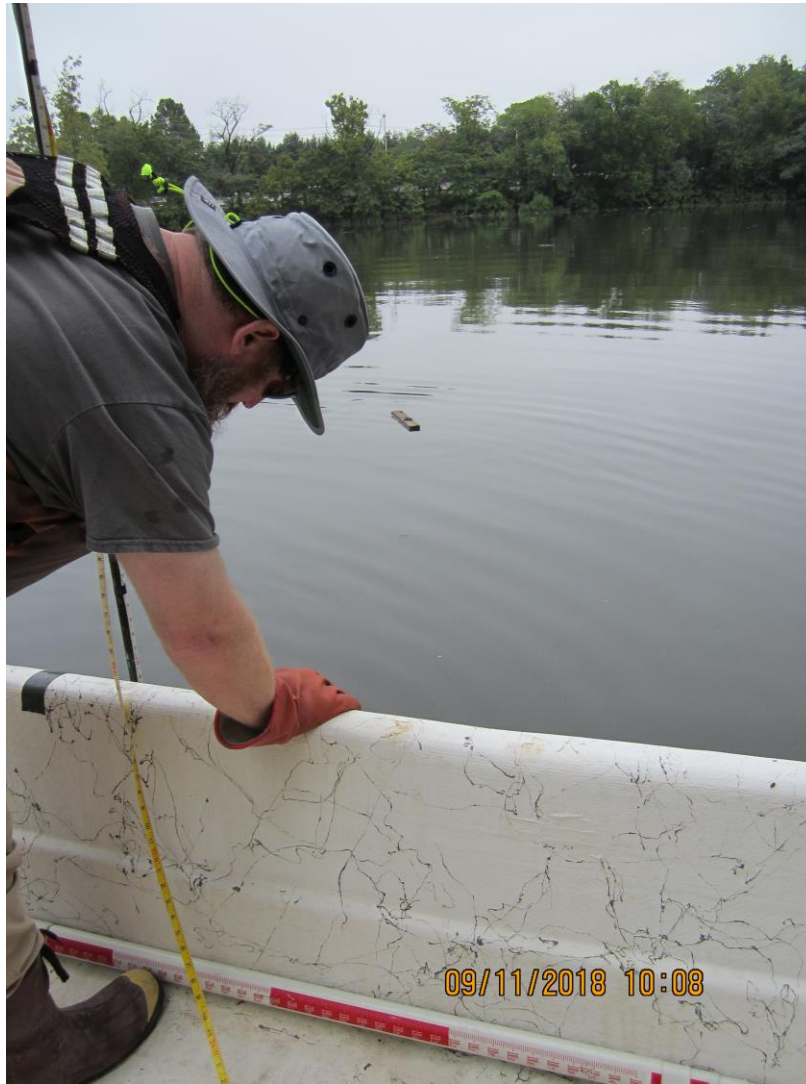
Photograph 5: Measuring depth to armor layer with long metal rod at D-1 location

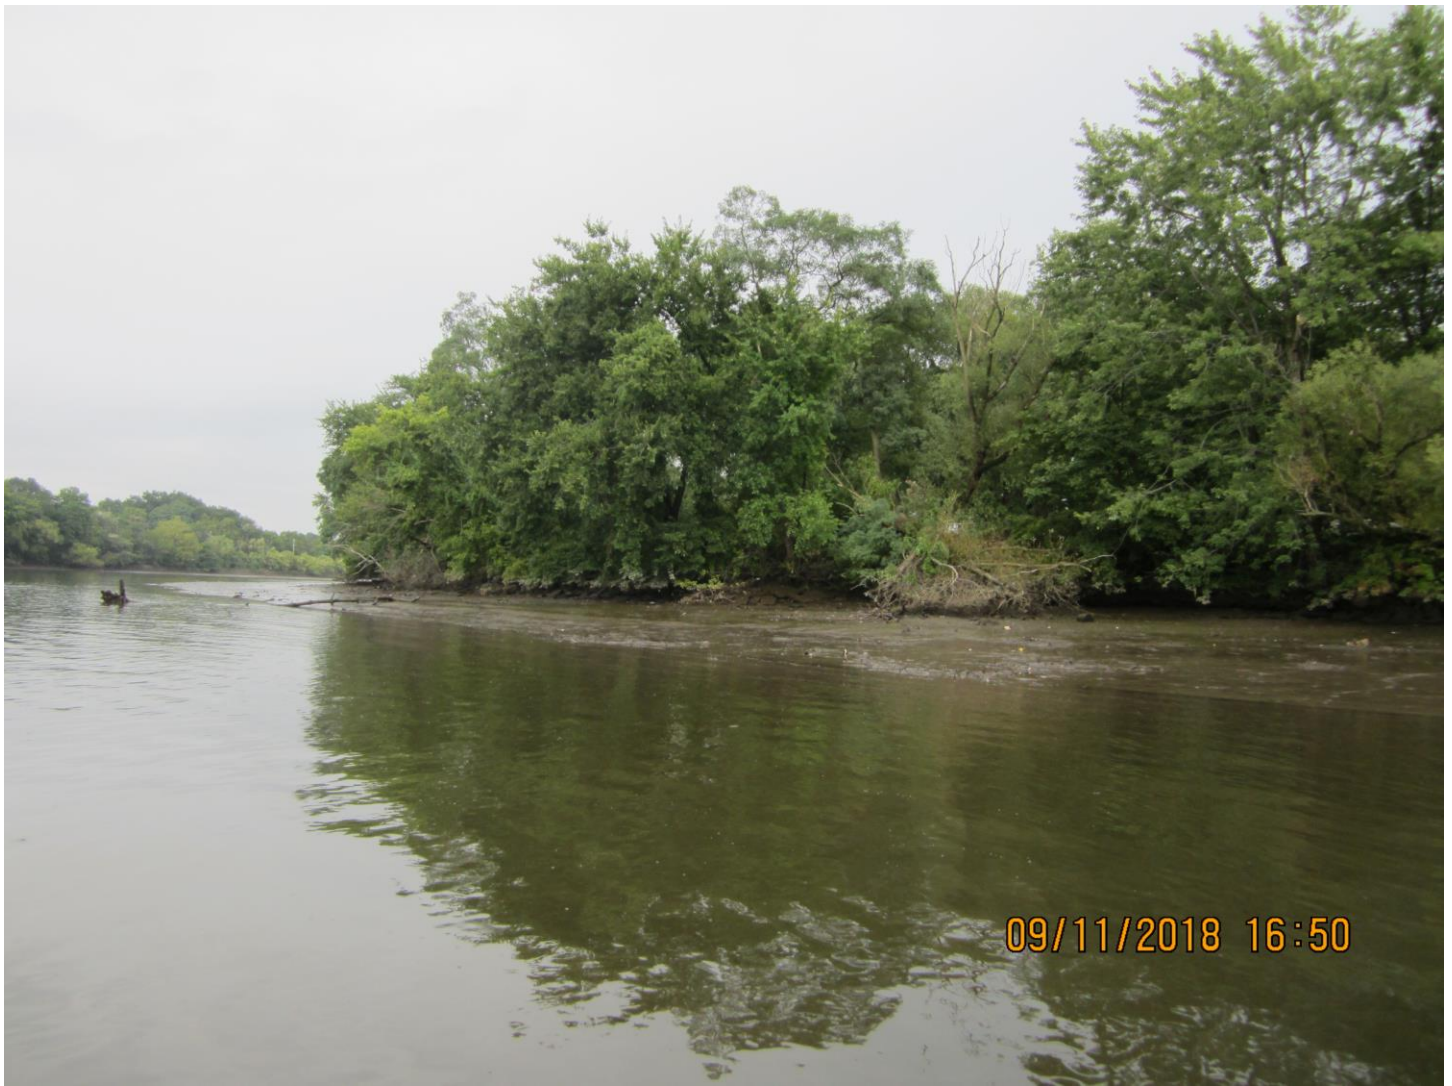
Photograph 6: Southern edge of cap around Transect X (facing northeast)

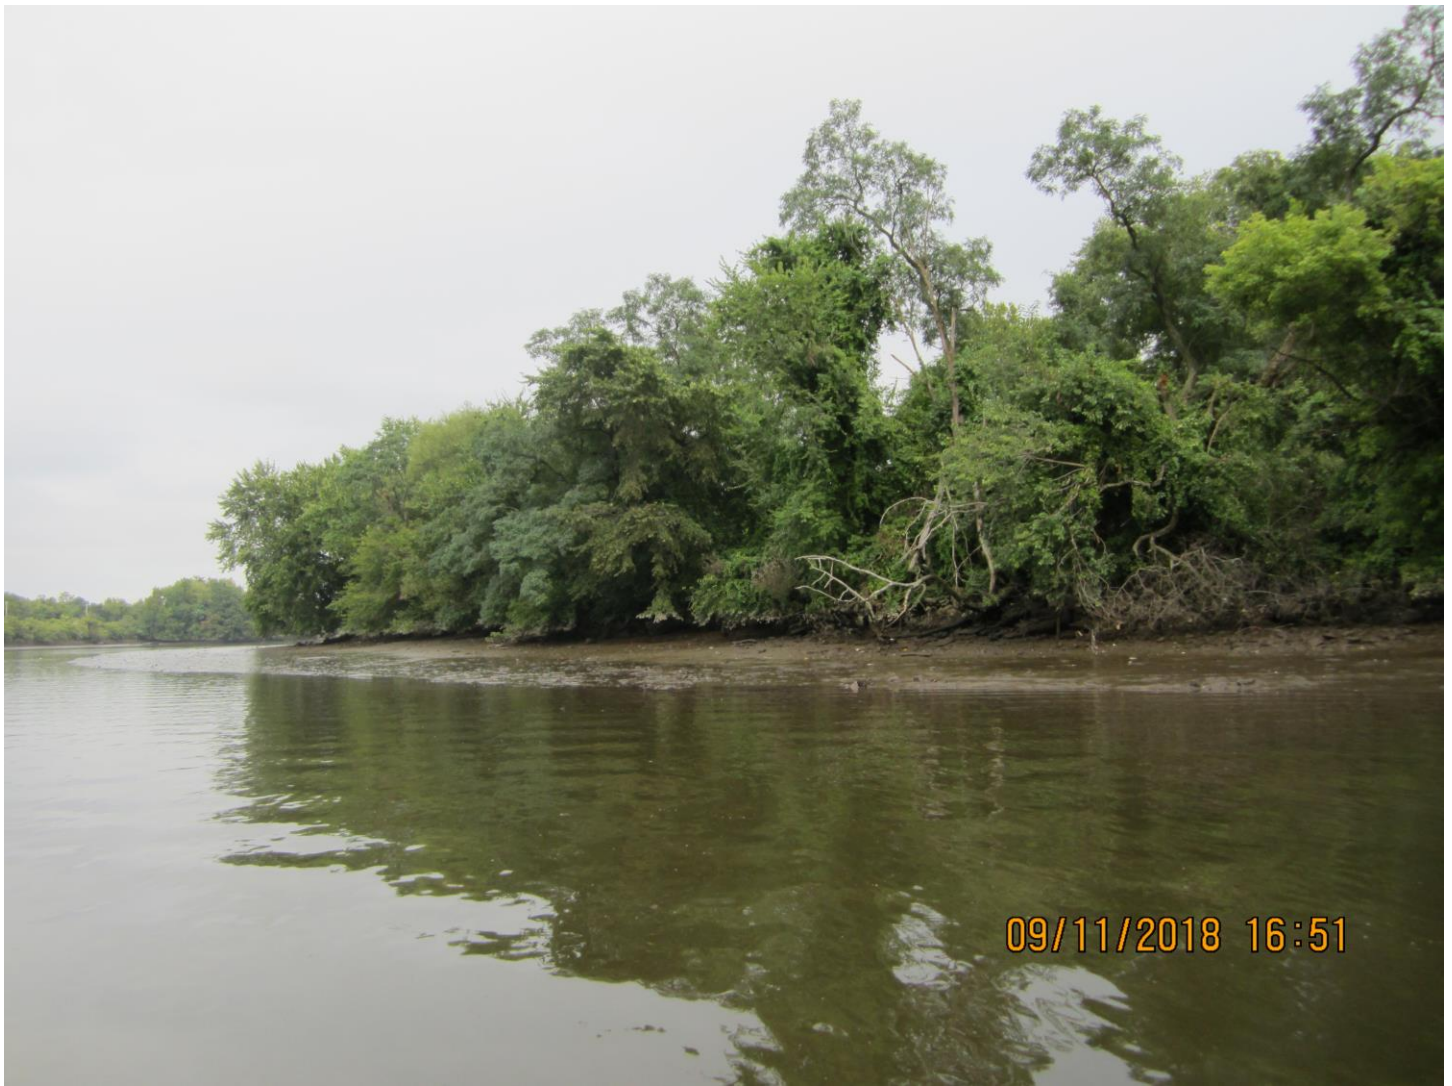
Photograph 7: Approximate area of Transect A (facing northeast)

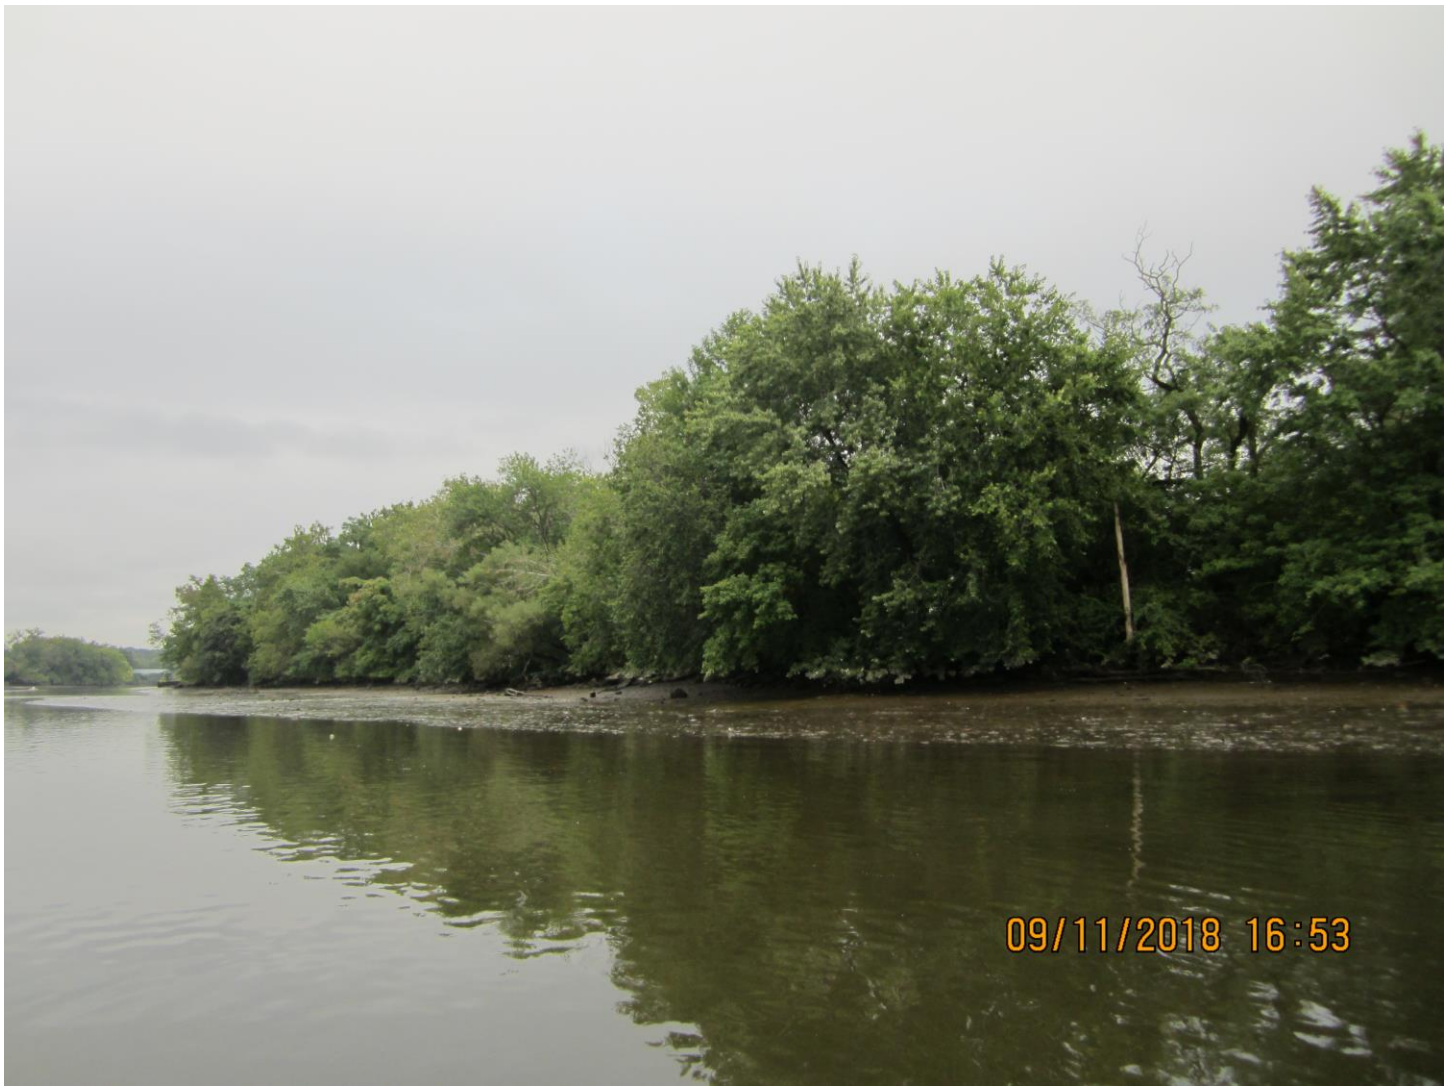
Photograph 8: Approximate area of Transects C and D (facing east)

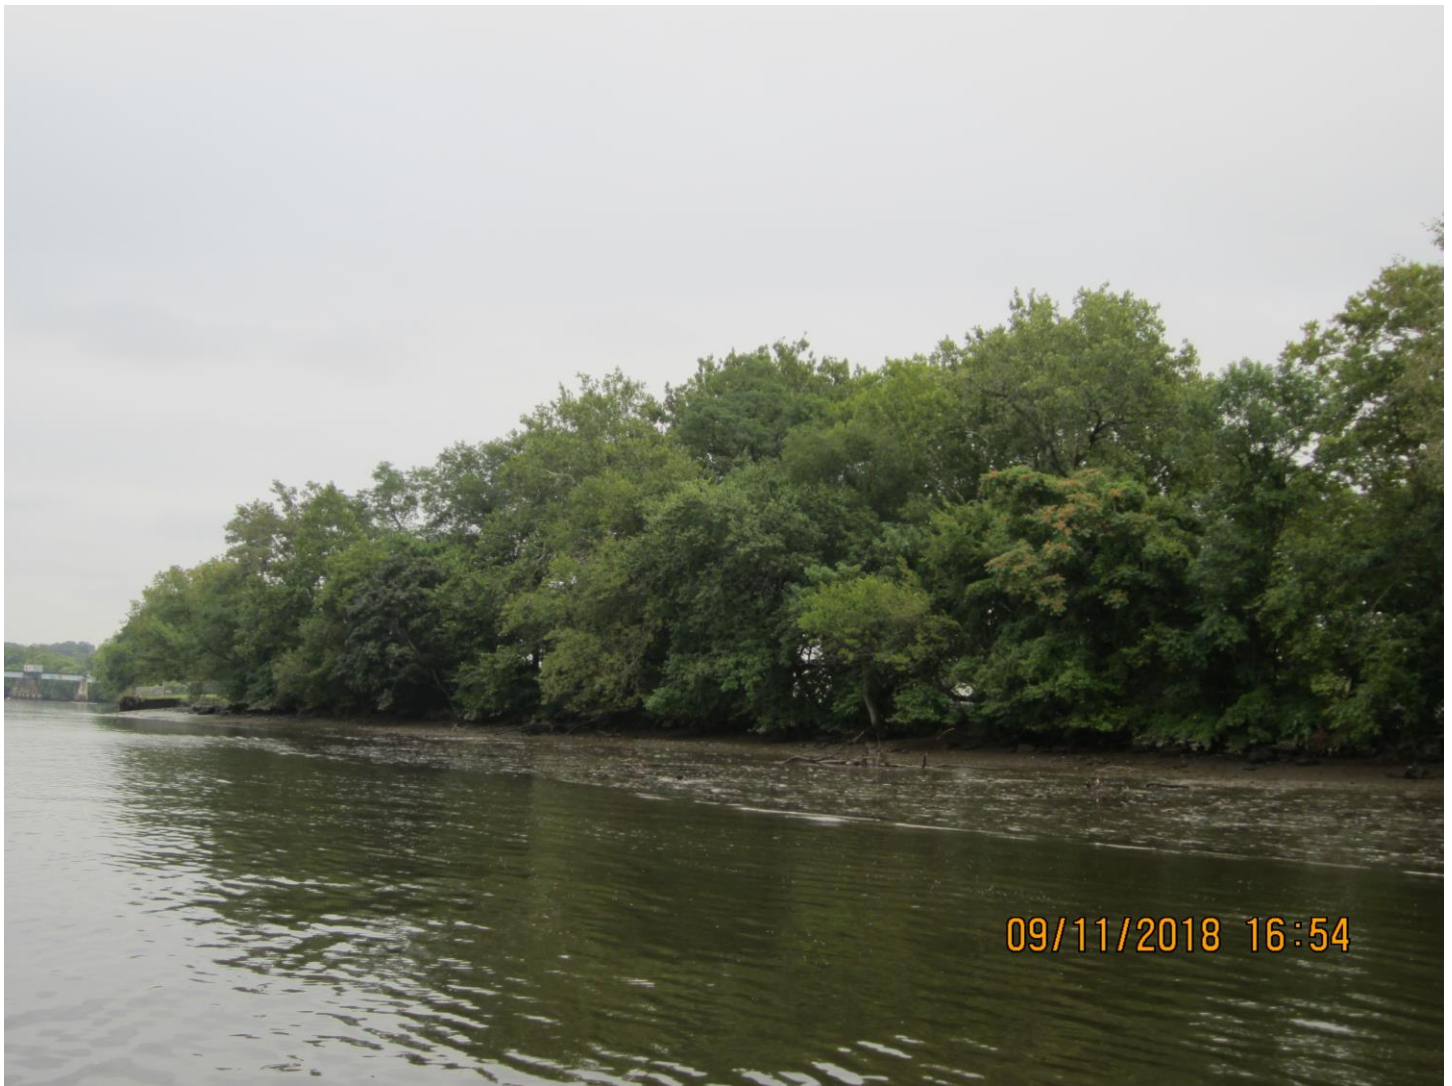
Photograph 9: Approximate area of Transect F from utility corridor (facing northeast)

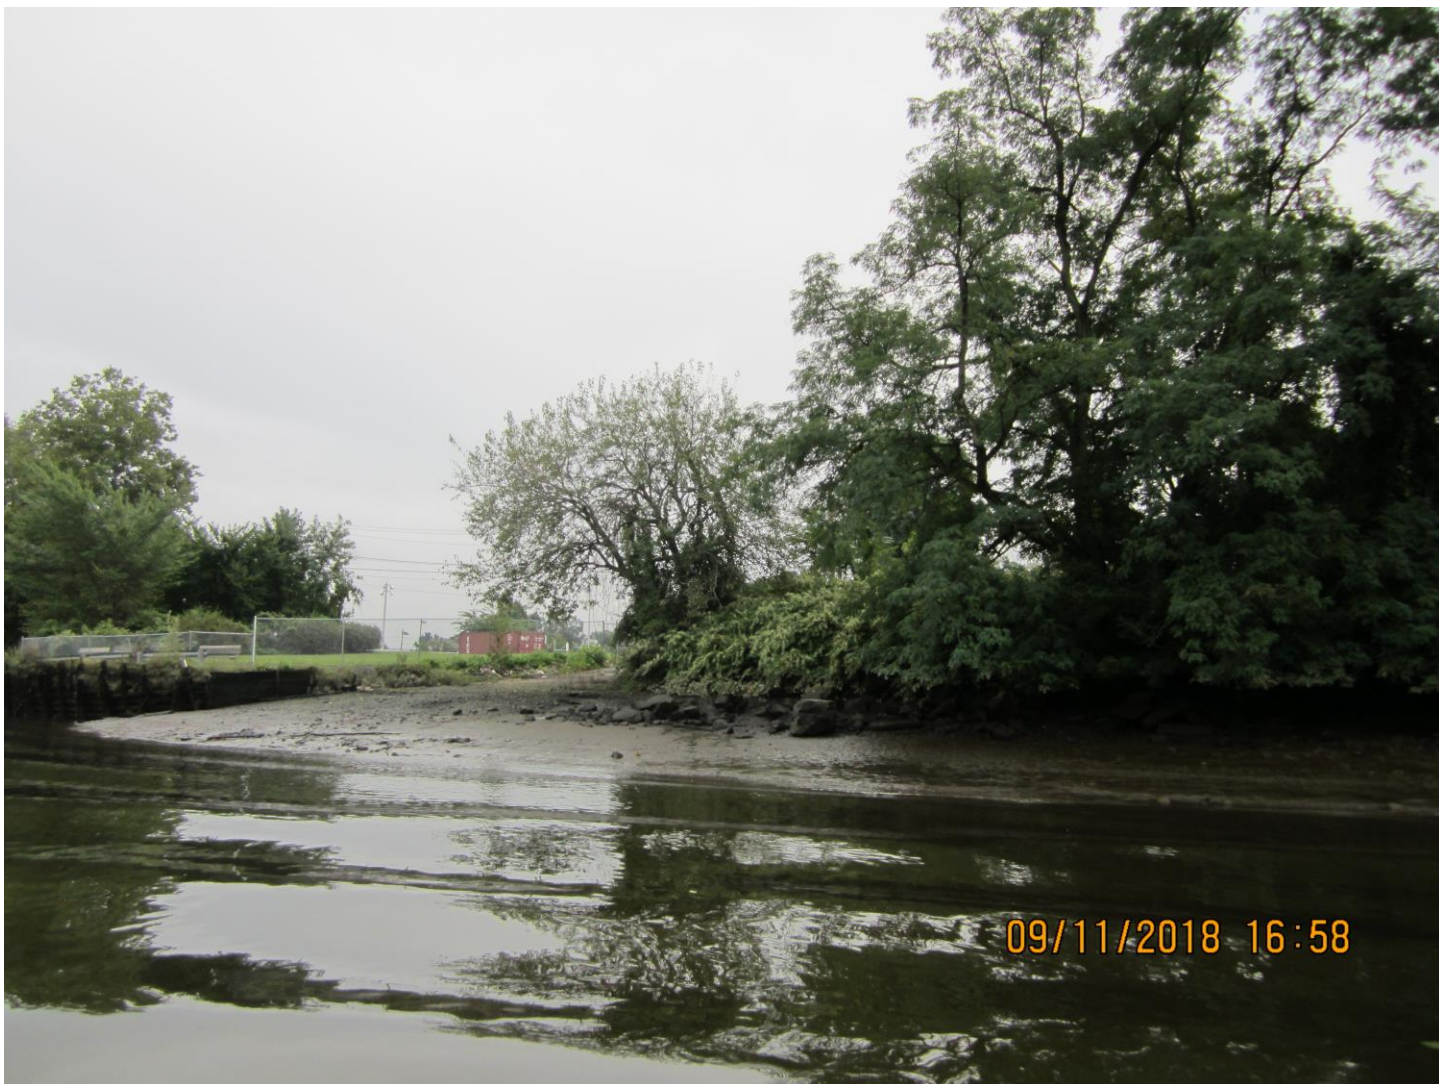
Photograph 10: Area of Transect H and adjacent boat ramp (facing east)

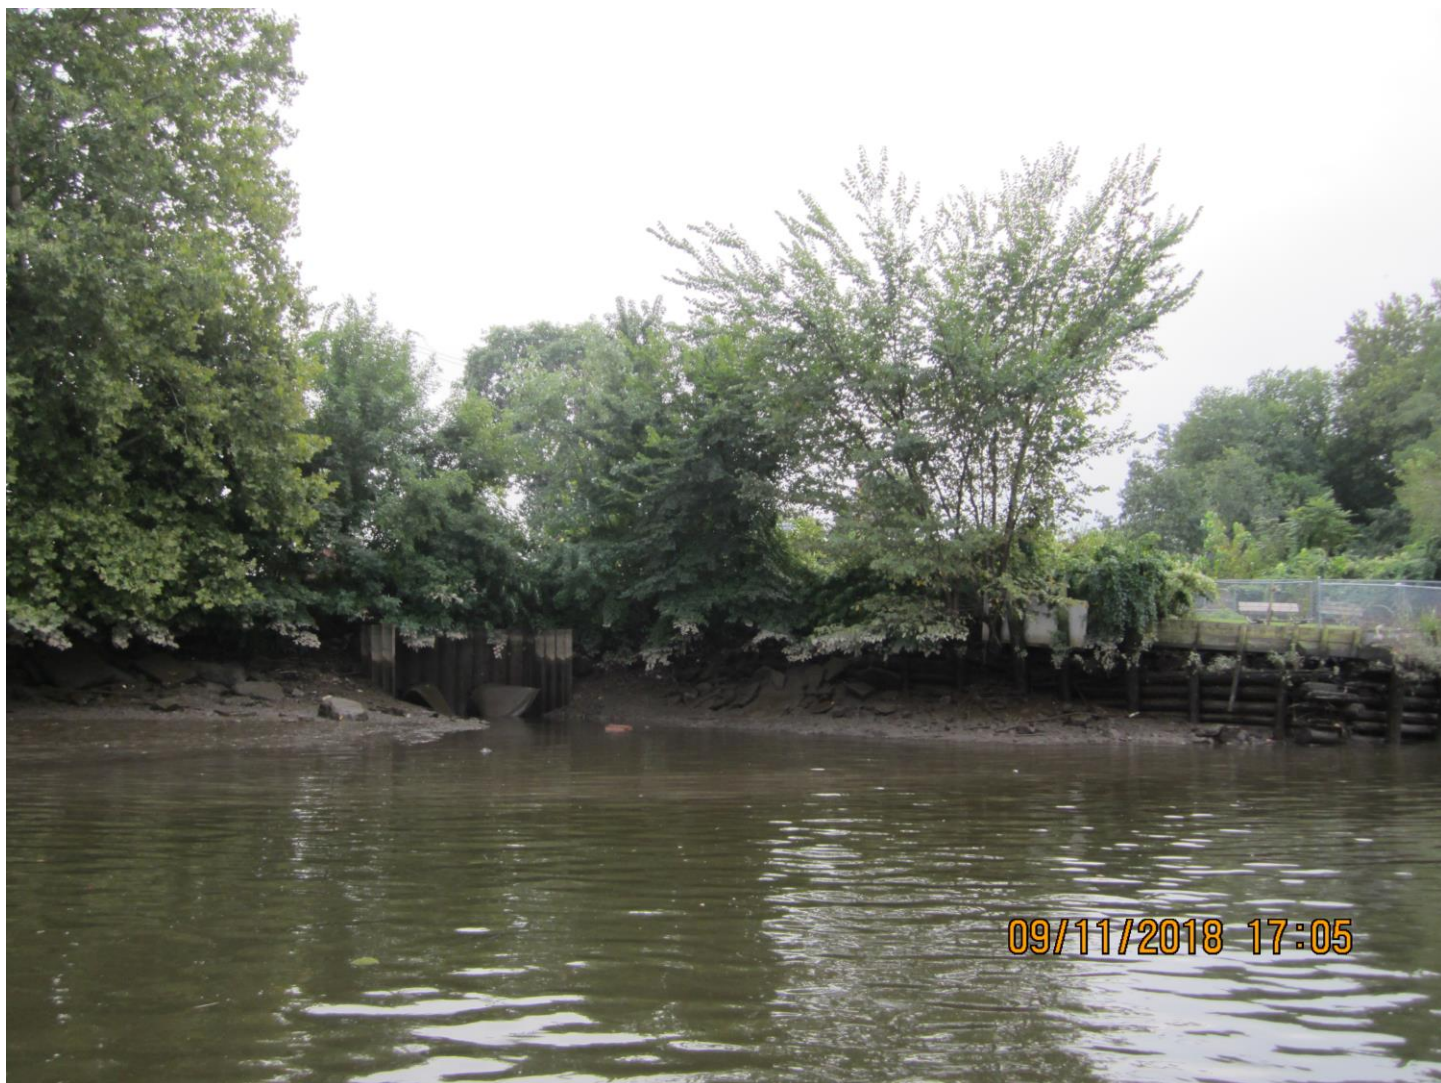
Photograph 11: Area of Transect I (facing southeast)

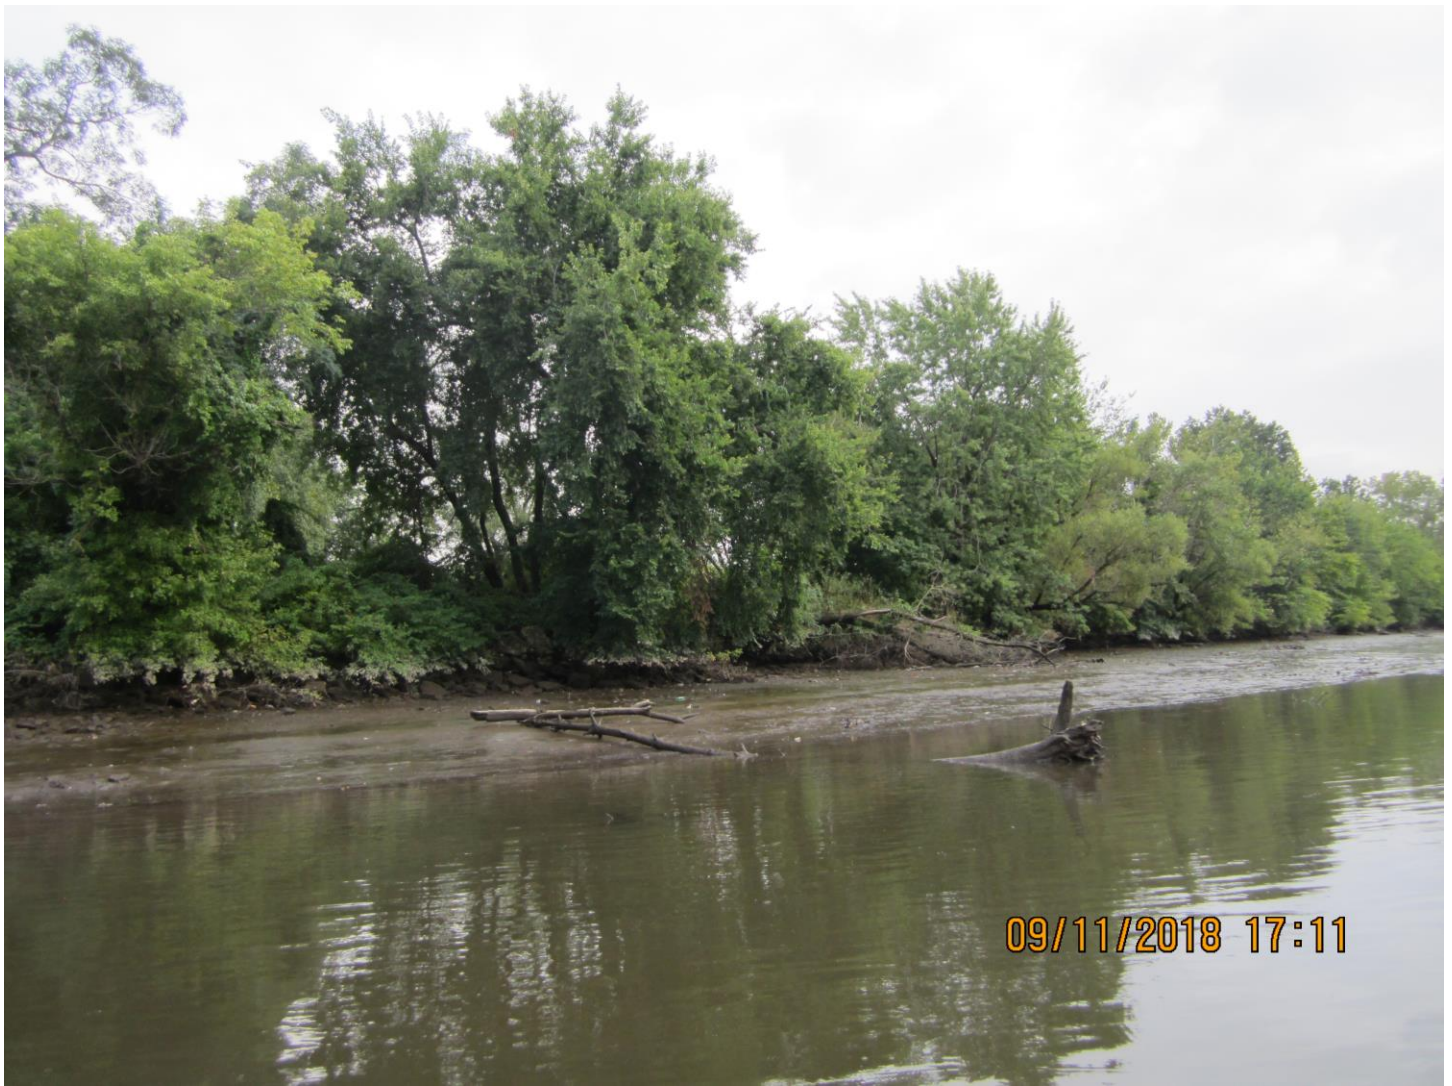
Photograph 12: Area of Transect B with fallen tree branch (facing southeast)

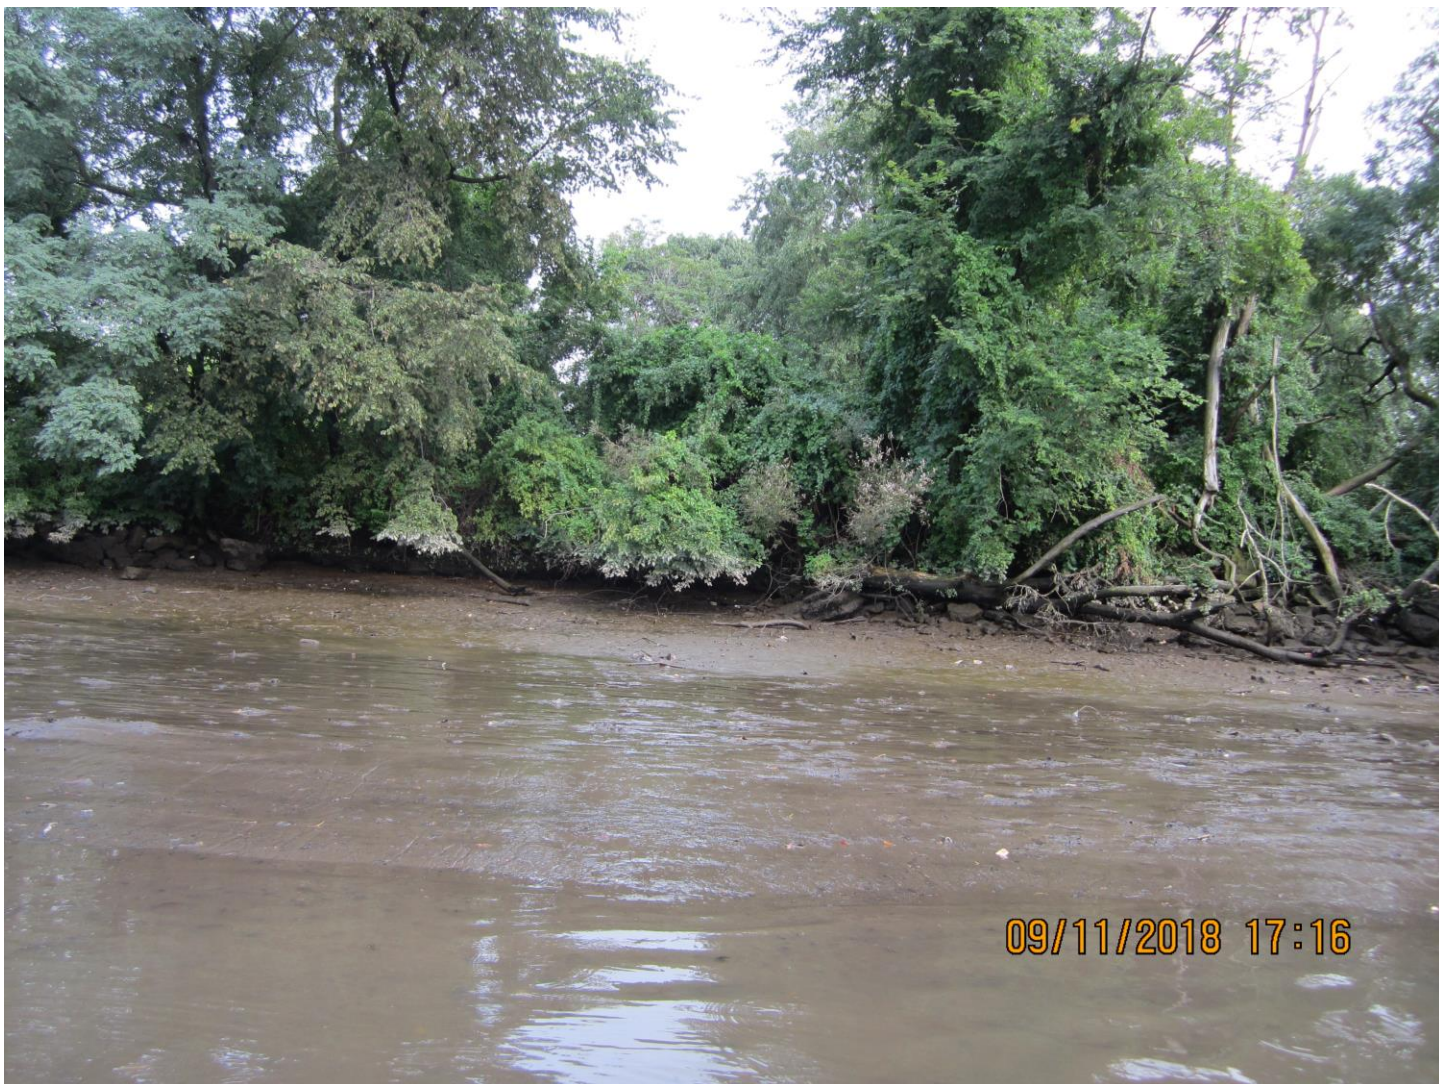
Photograph 13: Mudflats between Transects B and C (facing east)
